WL-TR-95-4108

**HIGH TEMPERATURES COATINGS
FOR TITANIUM ALUMINIDES**

**J. C. Schaeffer
R. L. McCarron**

**GENERAL ELECTRIC COMPANY - AIRCRAFT ENGINES
ENGINEERING MATERIALS TECHNOLOGY LABORATORIES
CINCINNATI, OHIO 45215-6301**

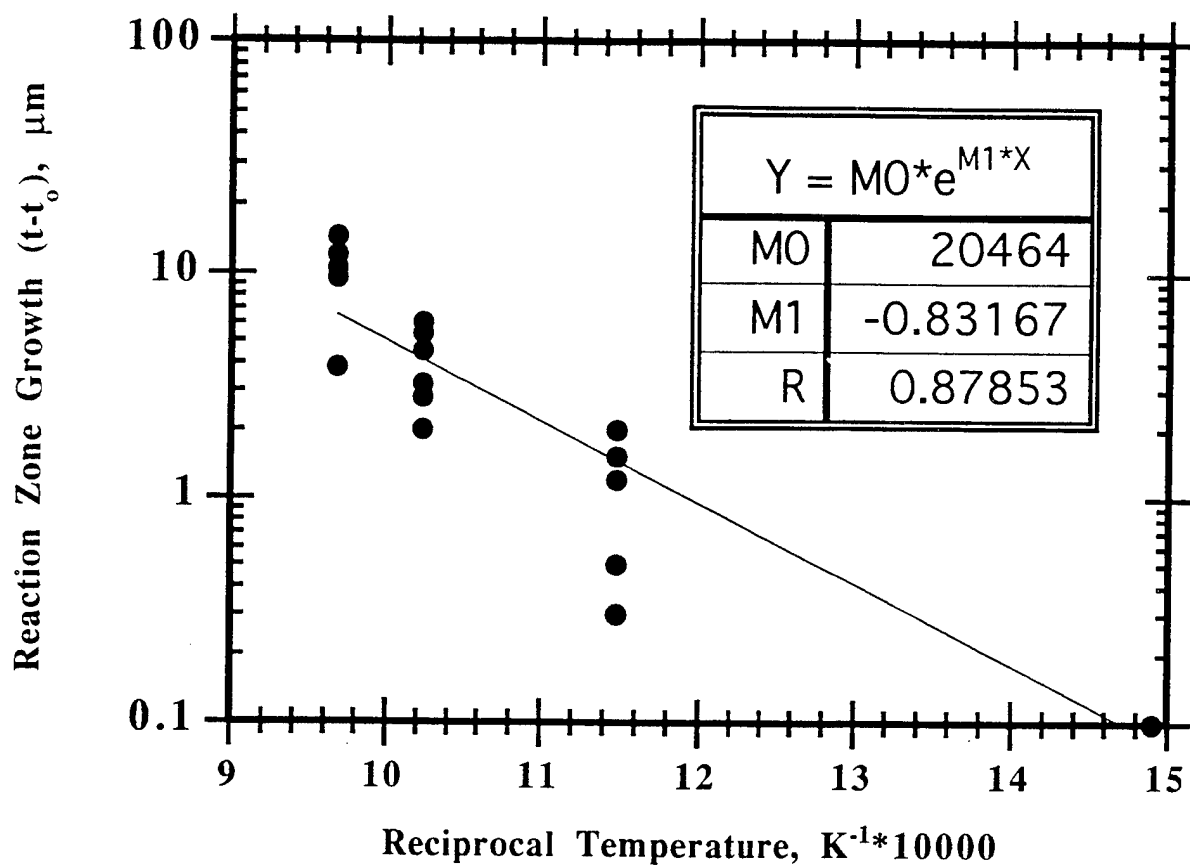
Figure 160. Graph summarizing reaction zone thickness as a function of peak exposure temperature. An equation that fits the line drawn through the data is shown in the figure.

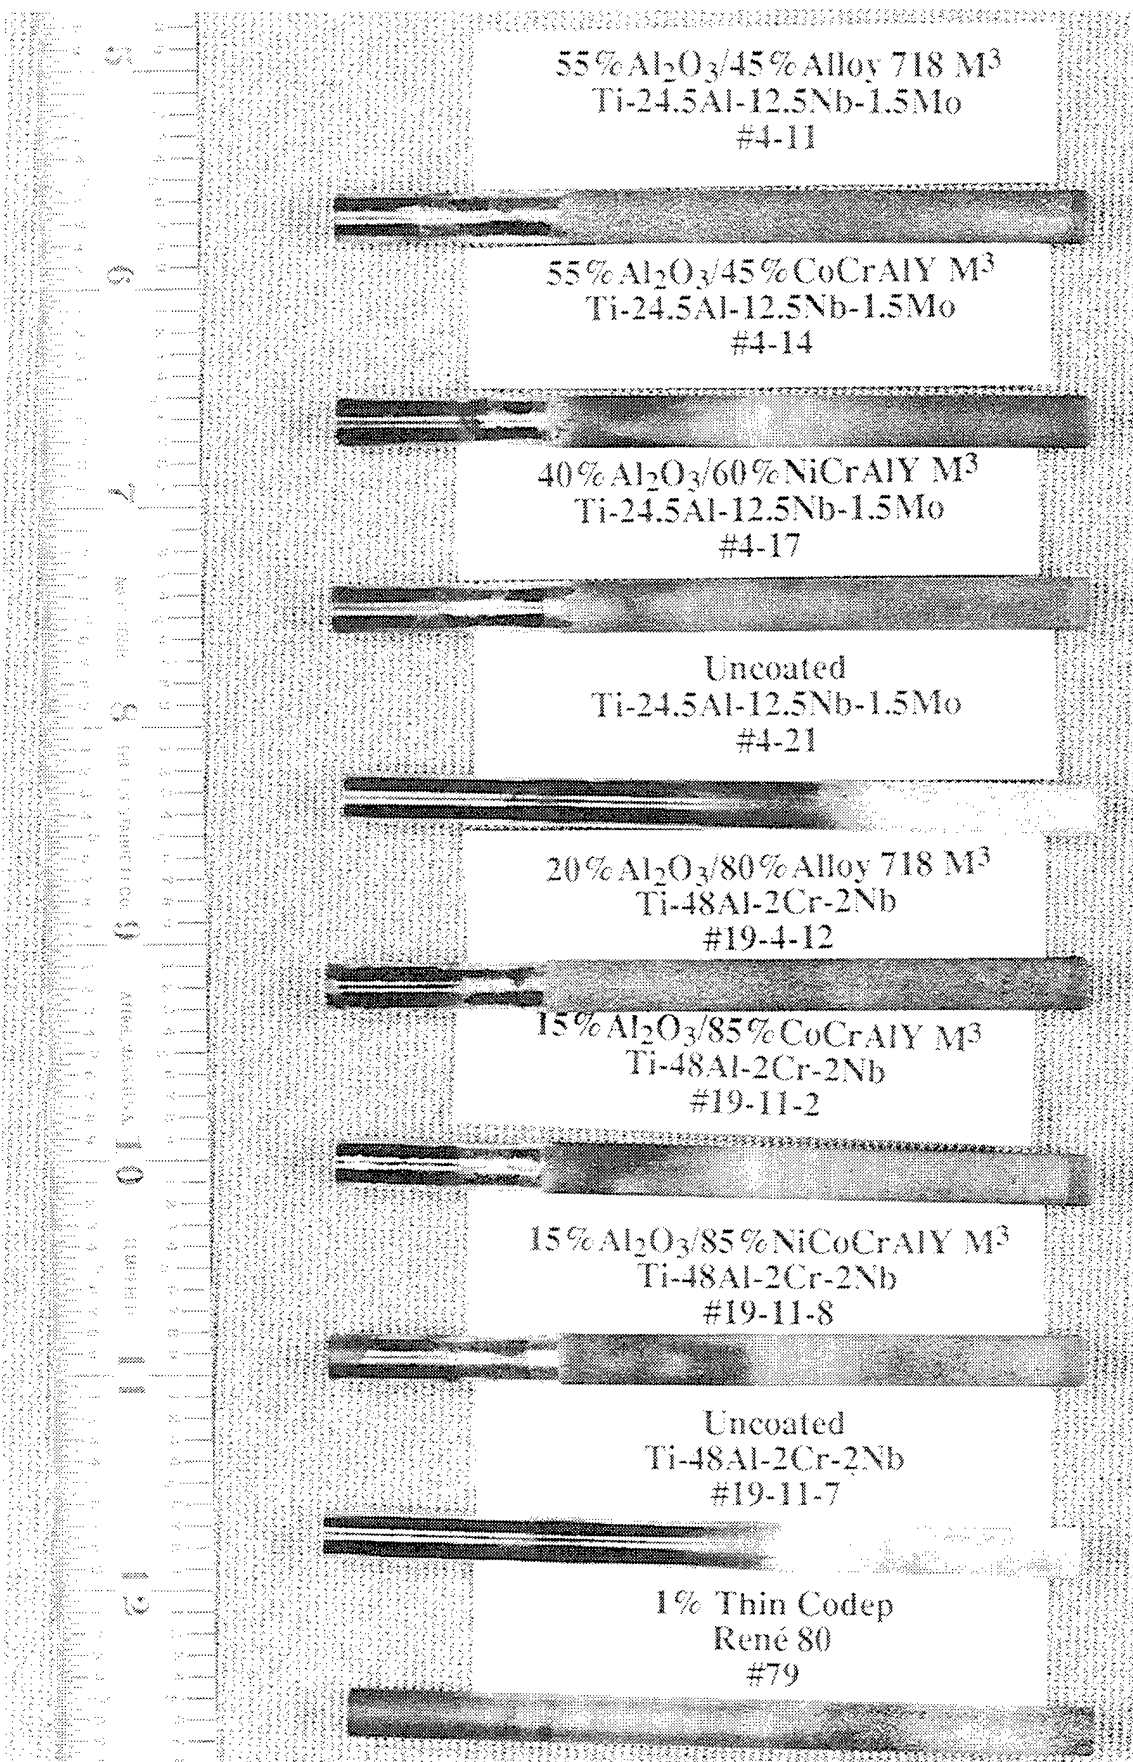
Figure 161. Color photograph of the back-side all of the pins after rinsing and 516 hours of burner rig testing at 871/760°C in 1-2ppm of sea salt. The figure allows comparisons between alpha-2 and gamma systems.

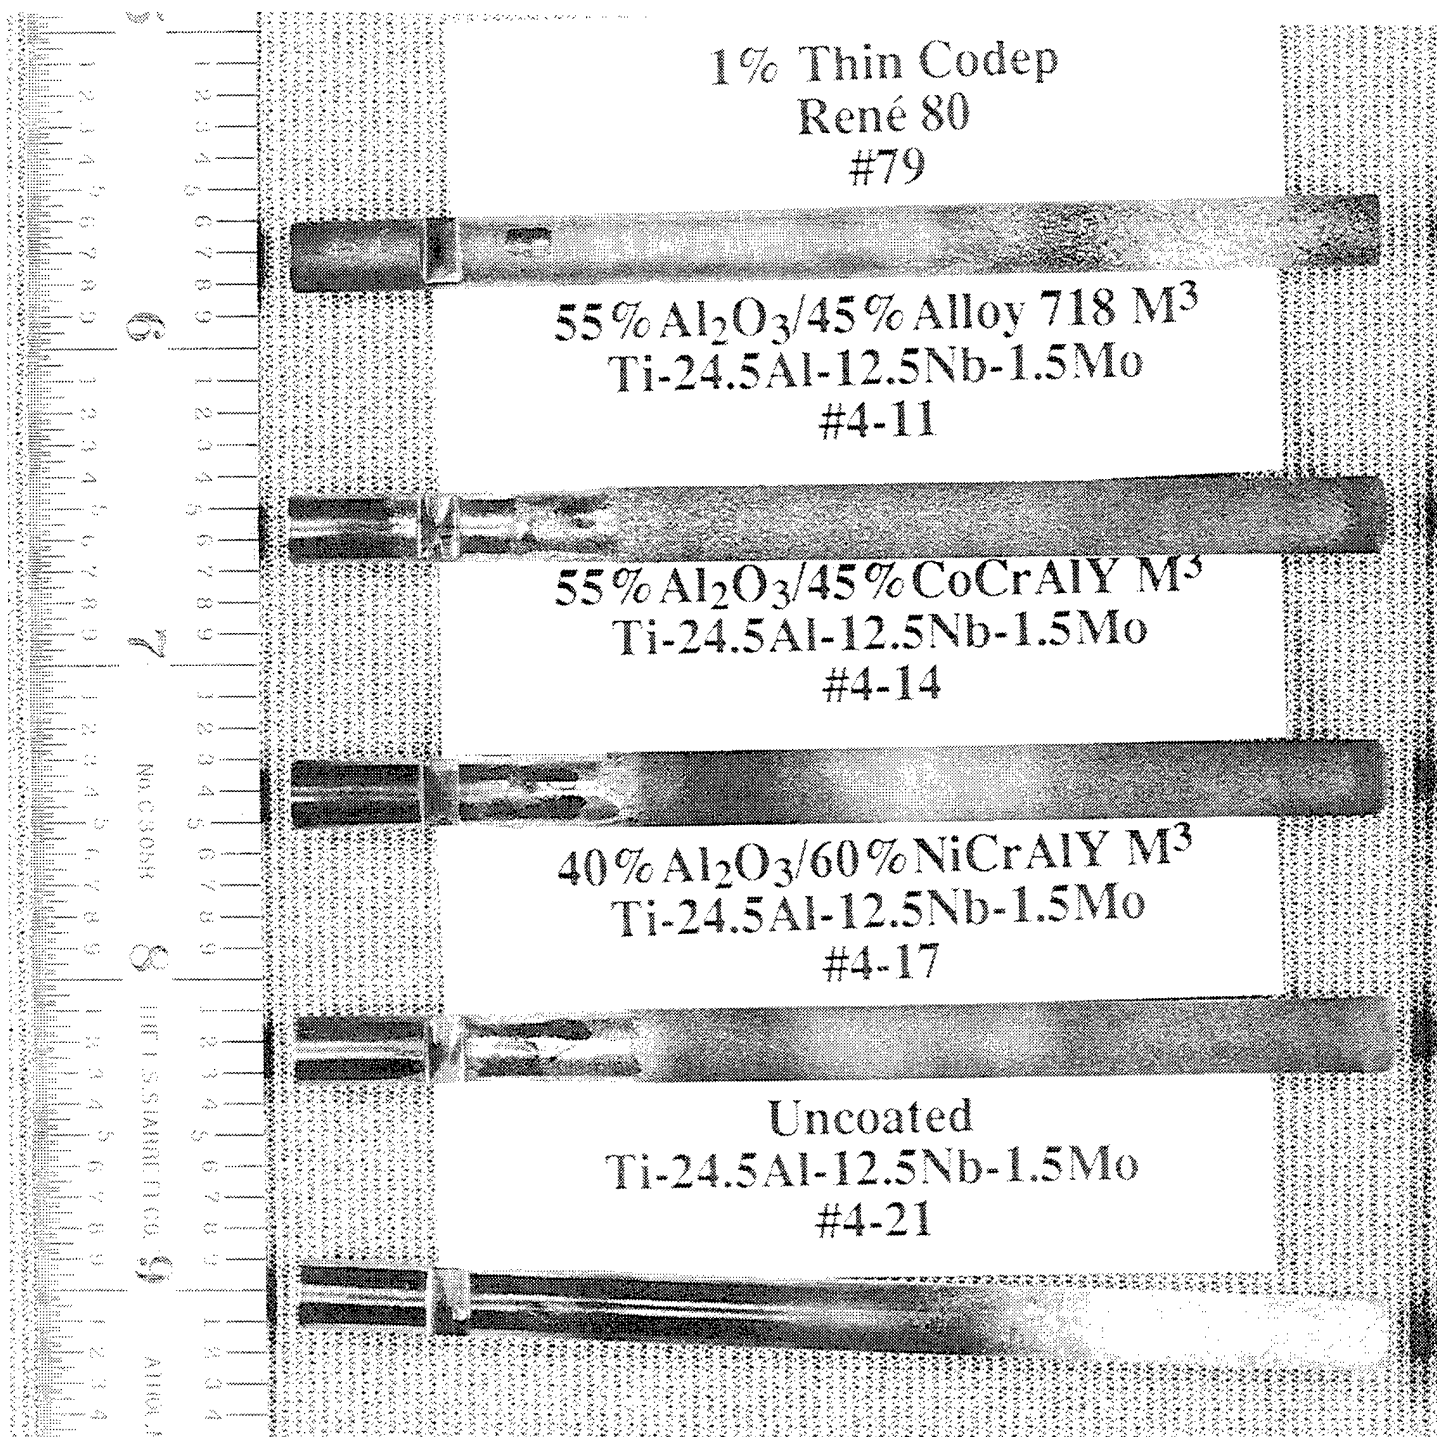
Figure 162. Color photograph of the flame-side of rinsed coated and uncoated alpha-2 after 516 hours of burner rig testing at 871/760°C in 1-2ppm of sea salt.

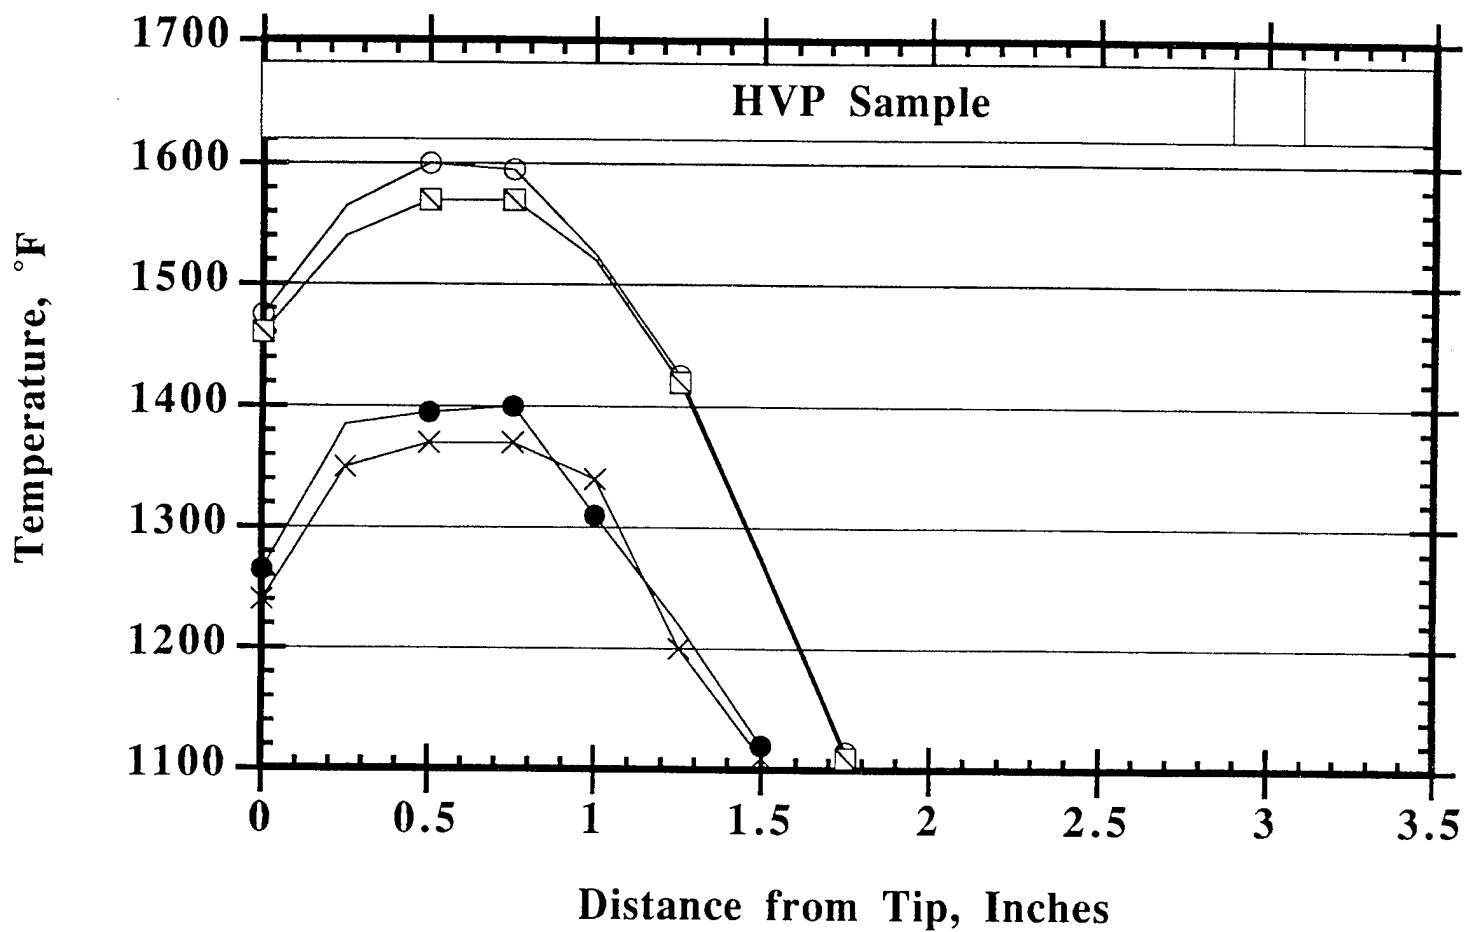
Figure 164. Graph showing the temperature distribution along the length of the pin for the 871/760°C burner rig test.

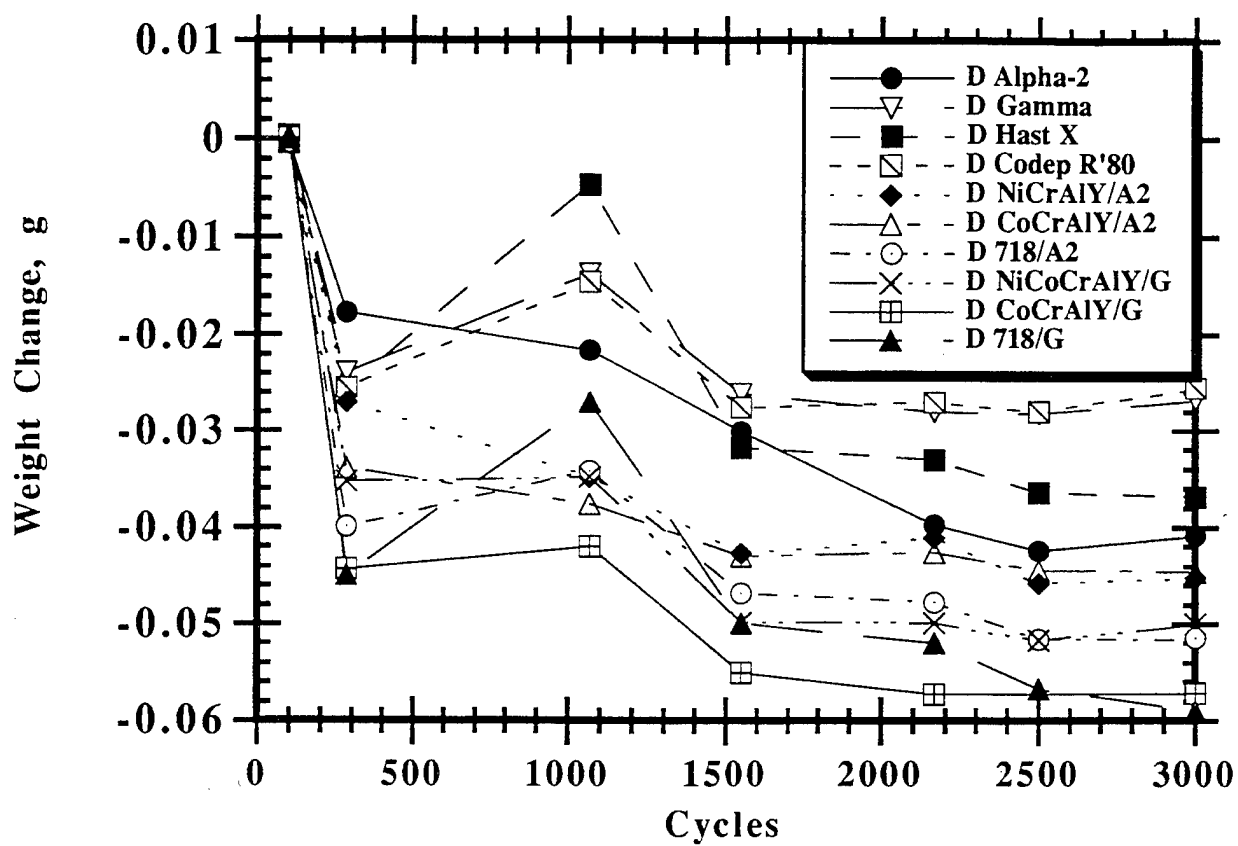
Figure 165. Graph showing the weight change after rinsing for coated and uncoated samples during the 871/760°C burner rig test.

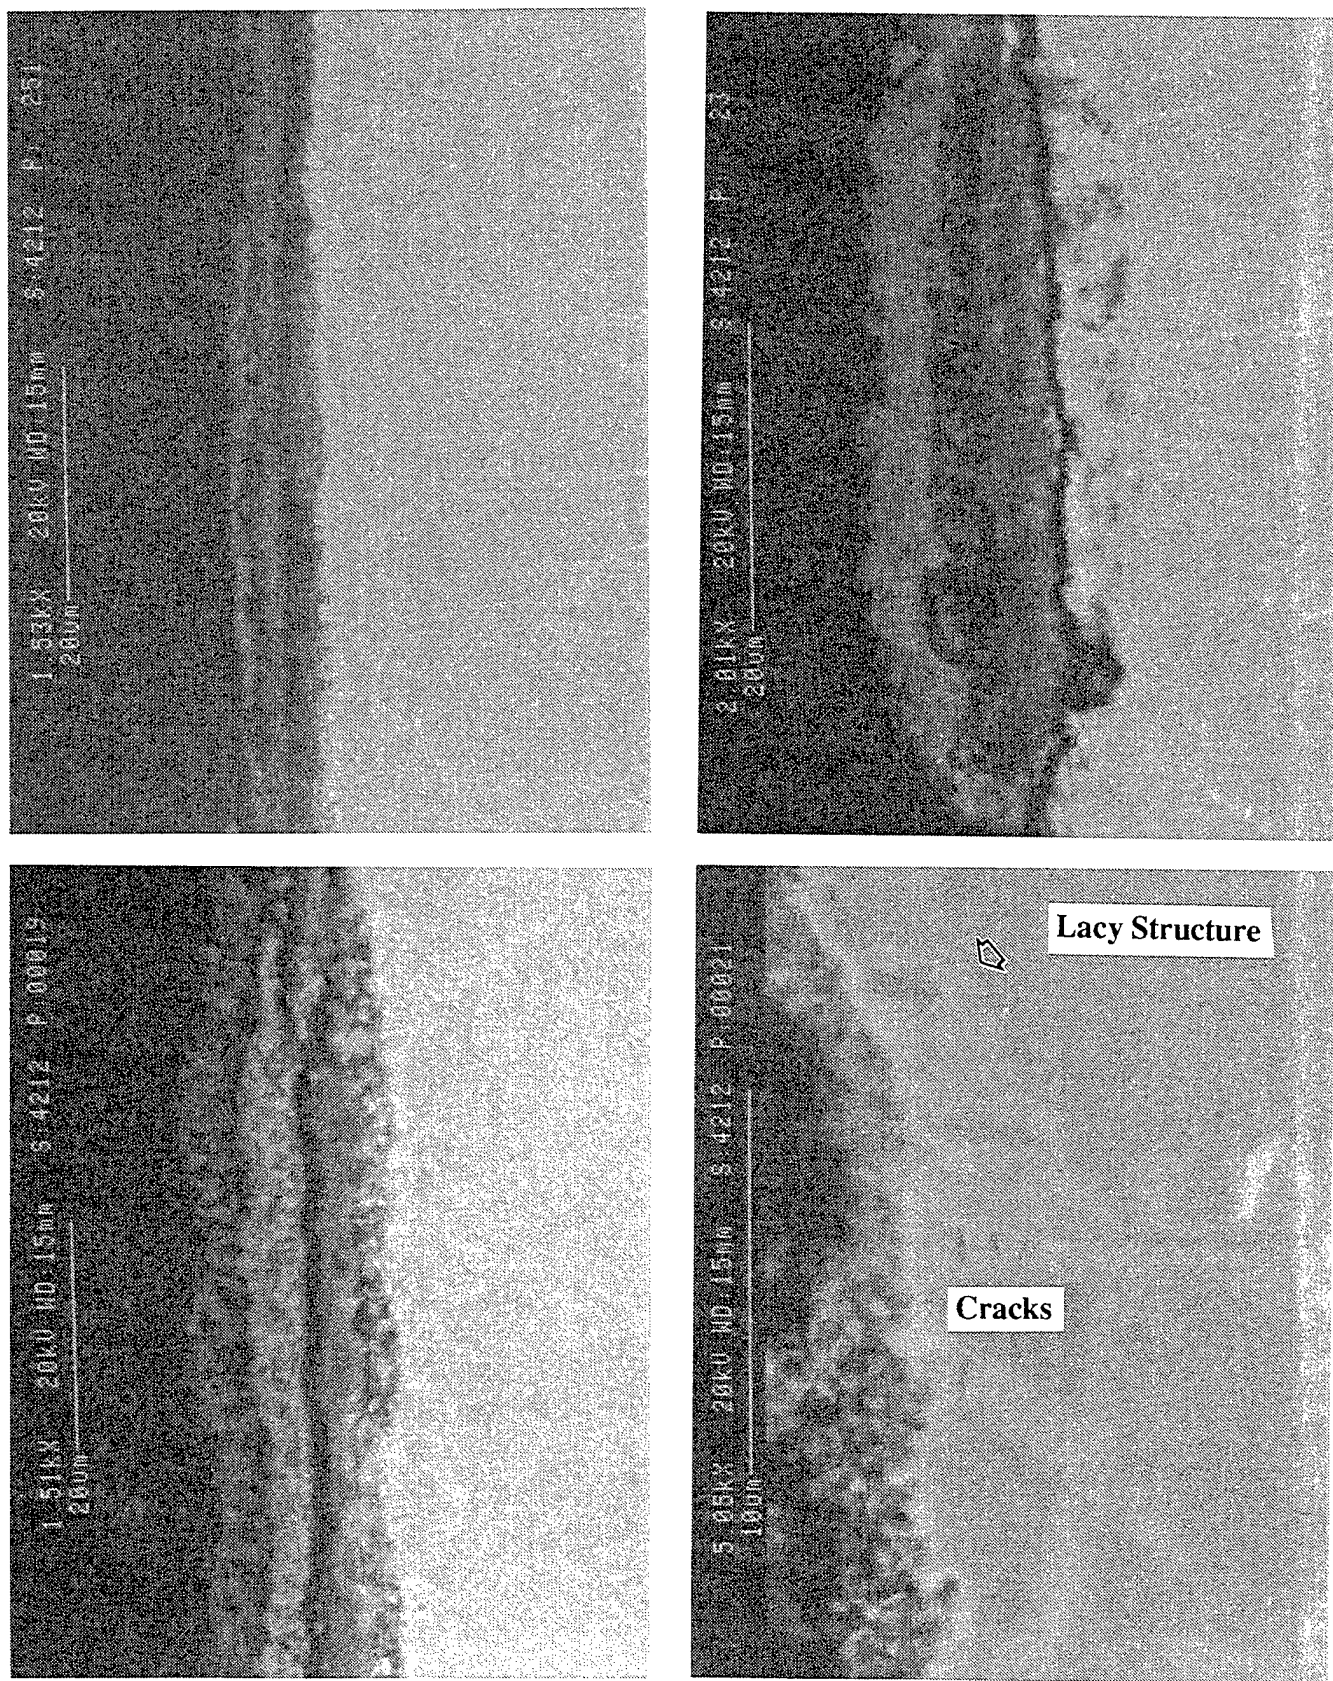
Figure 167. Micrographs showing the attack of uncoated gamma in the 871°C section. Thick oxide scales formed as well as a lacy microstructure in the gamma substrate that was prone to cracking.

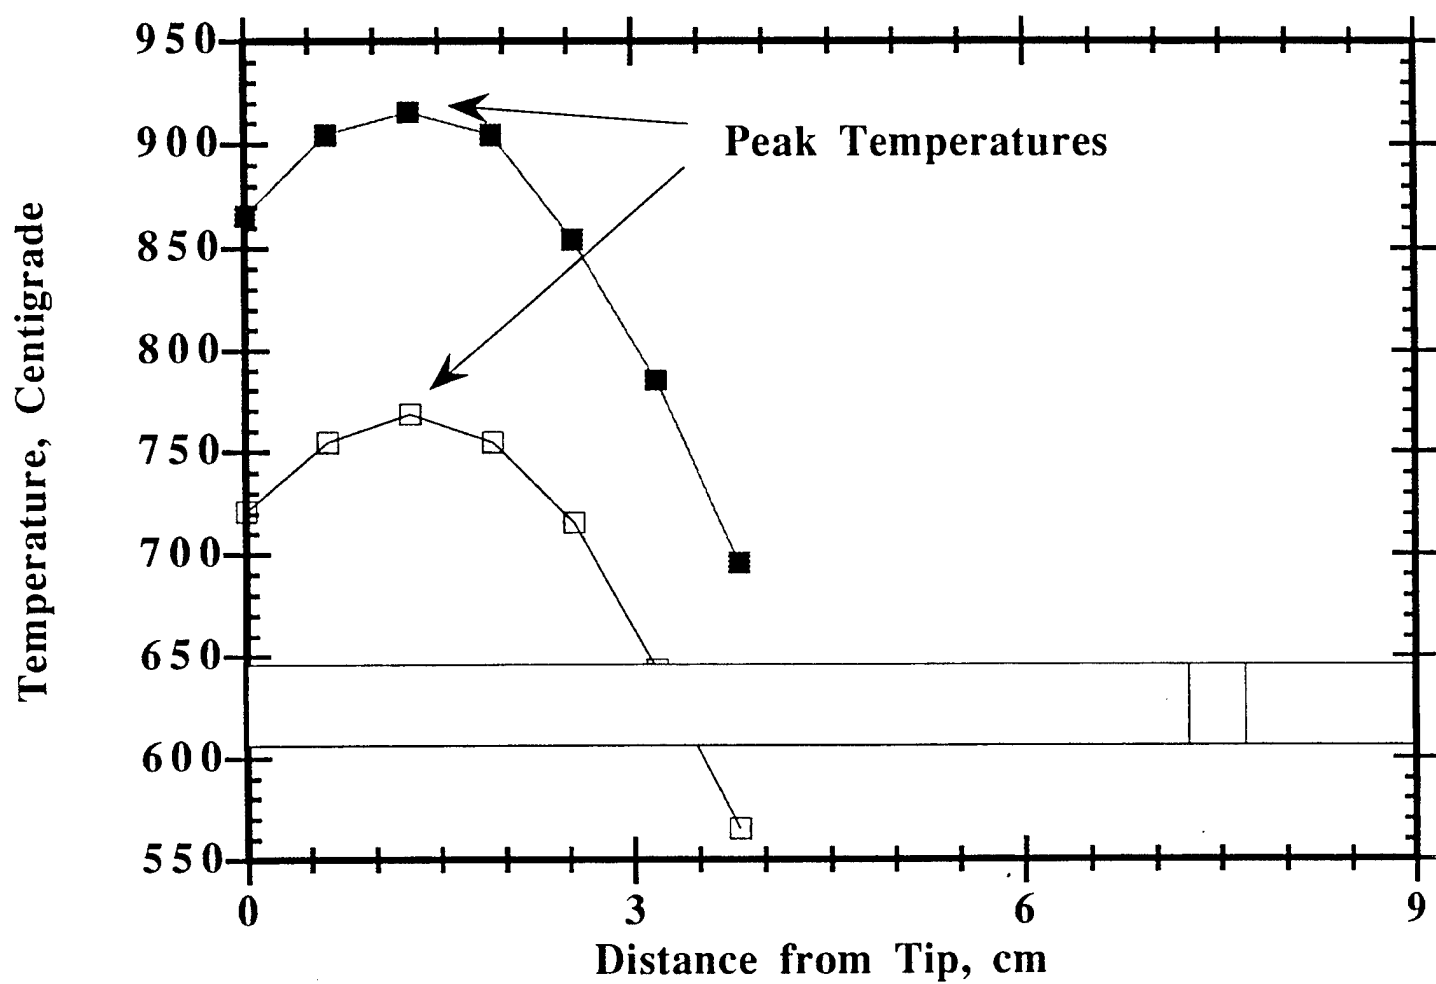
Figure 177. Graph showing the temperature distribution in pins tested in the 900/760°C burner rig test without salt.

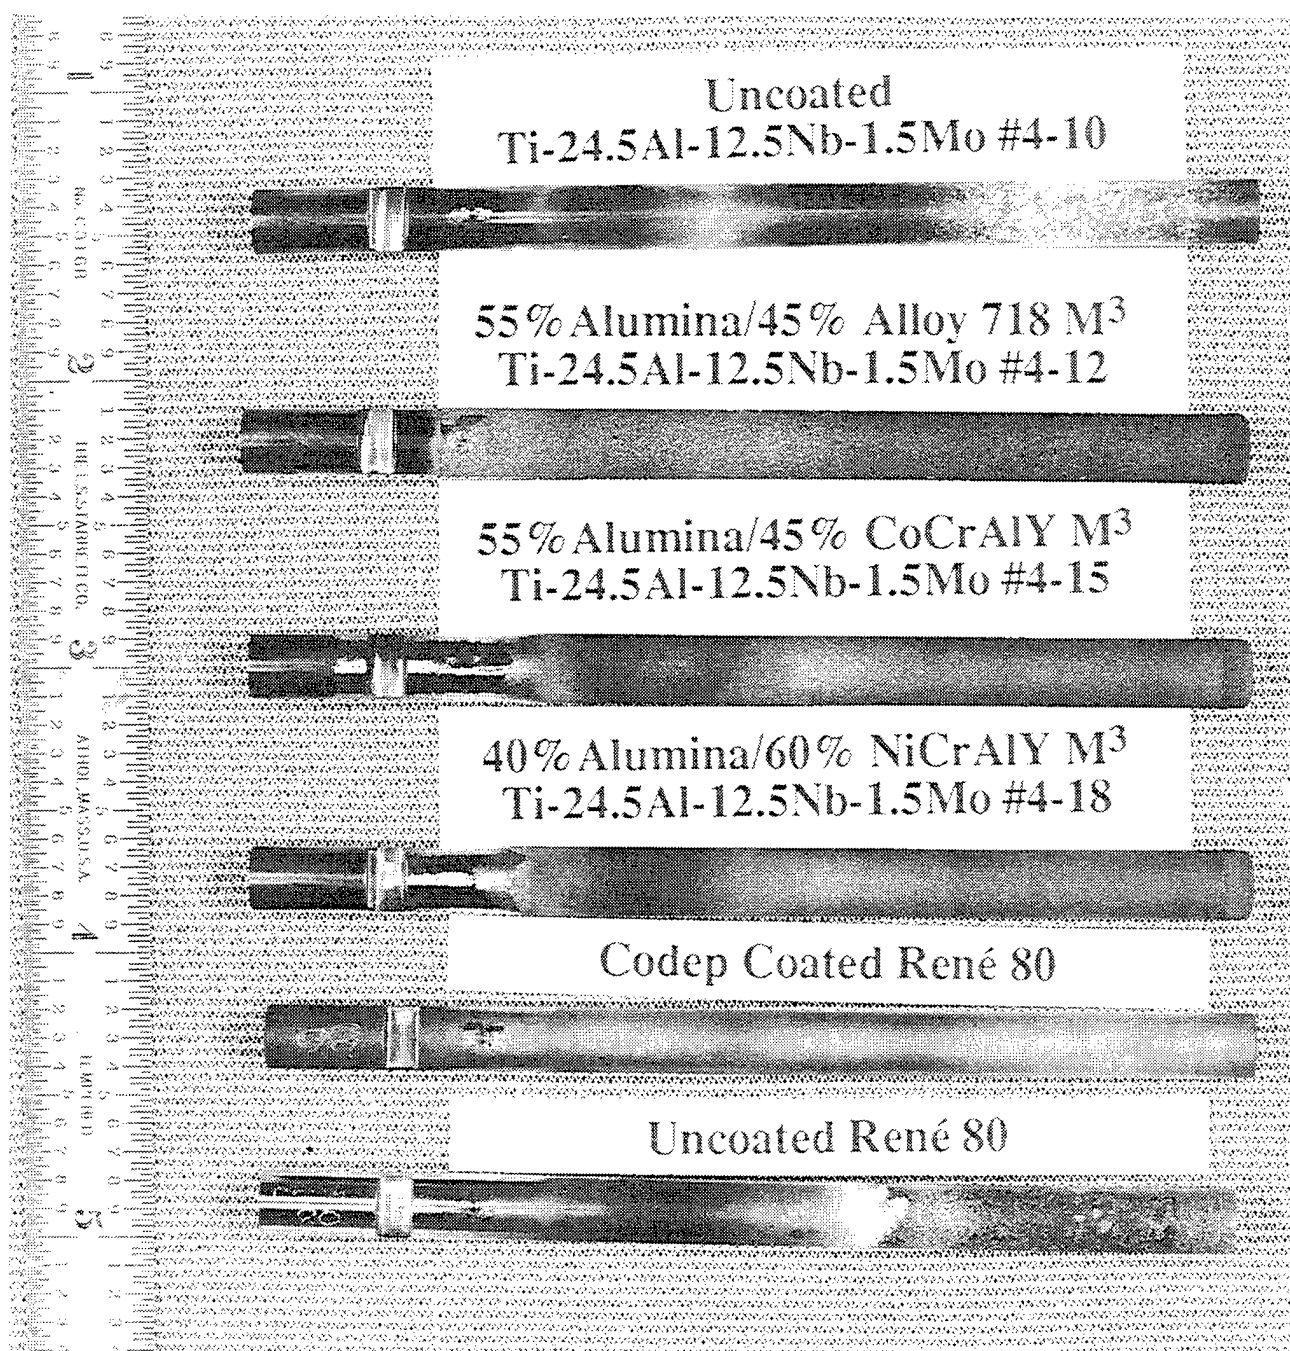
Figure 178. Color photograph showing the alpha-2 systems after the 900/760°C burner rig test with no salt.

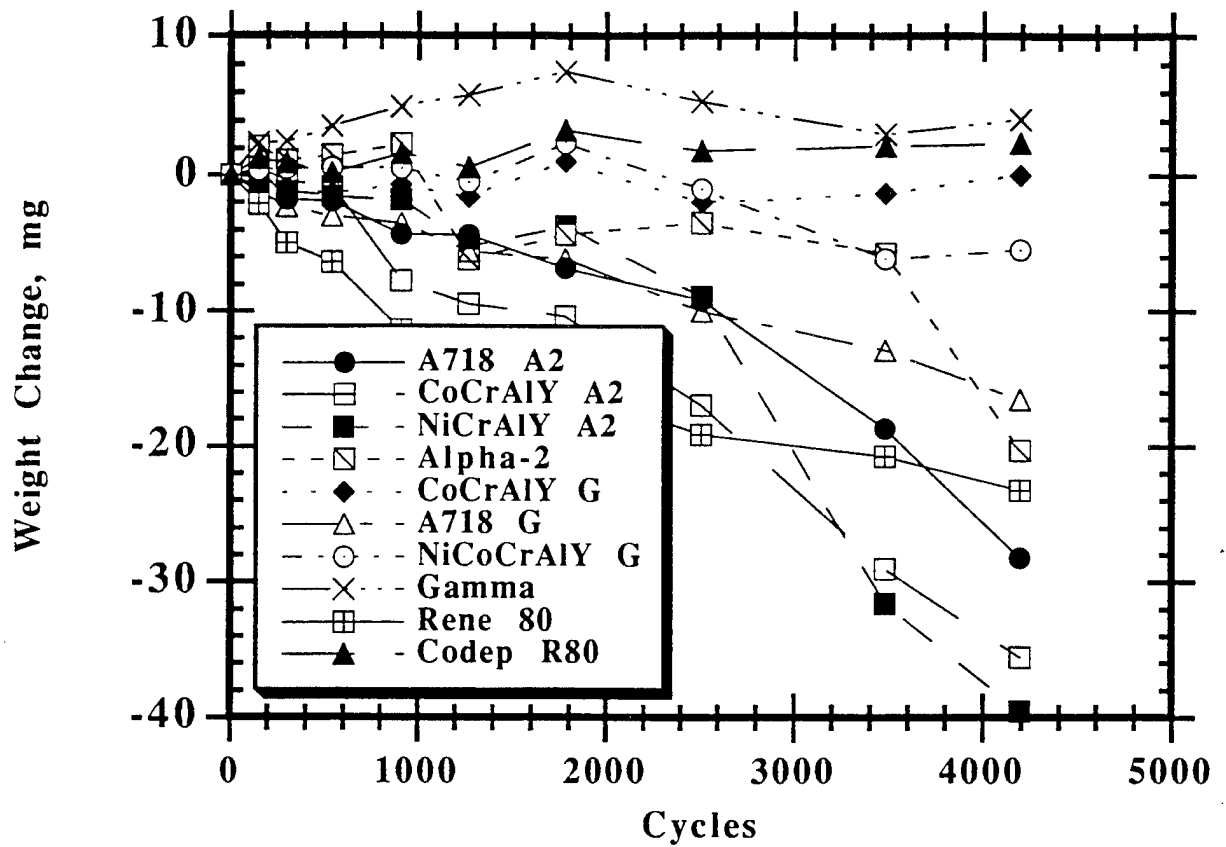
Figure 180. Graph showing the weight change of all the samples during the 900/760°C burner rig test with no salt.

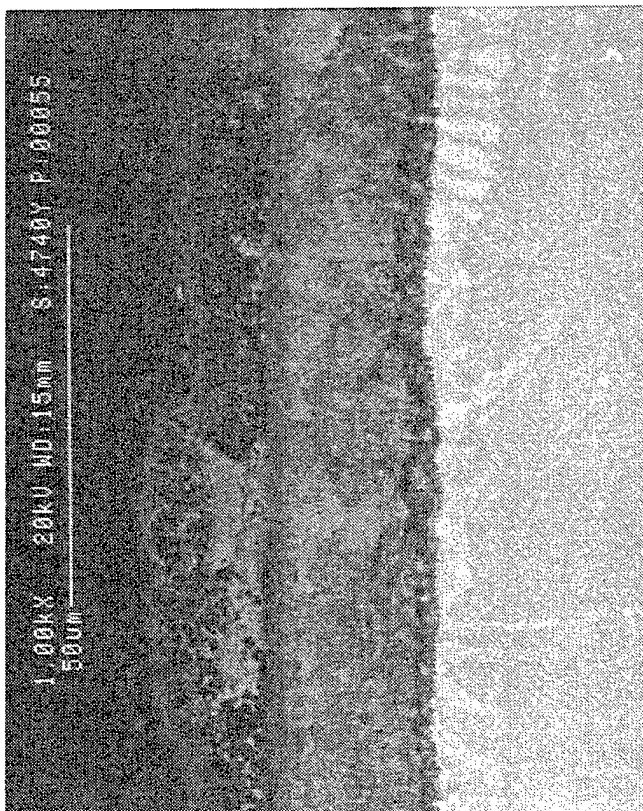
Figure 181. Micrographs showing the 900°C section of the uncoated gamma after 900/760°C burner rig testing with no salt. The lacy or cellular morphology develops under the scale.

Figure 181 shows cross-sections of the uncoated Ti-48Al-2Cr-2Nb gamma alloy in the hottest section. In one area, a ~50µm thick oxide composed of two distinct layers was observed. The external oxide was cracked and layered and appeared to form from outward transport of cations. The gray regions were titania and darker regions of alumina. The internal oxide had features that indicated that the substrate was converted to oxide as an oxidation front moved inward, i.e., formed by anion movement. Ahead of the front, the alloy transformed to the lacy structure observed in other hot corrosion producing environments. EDS analyses indicated that the matrix of the cellular product had a Ti:Al ratio of 3:1 indicating alpha-2 with a trace of Cr and Nb. The fingers in the phase were a little richer in Al and Nb. No oxygen was observed in the cellular

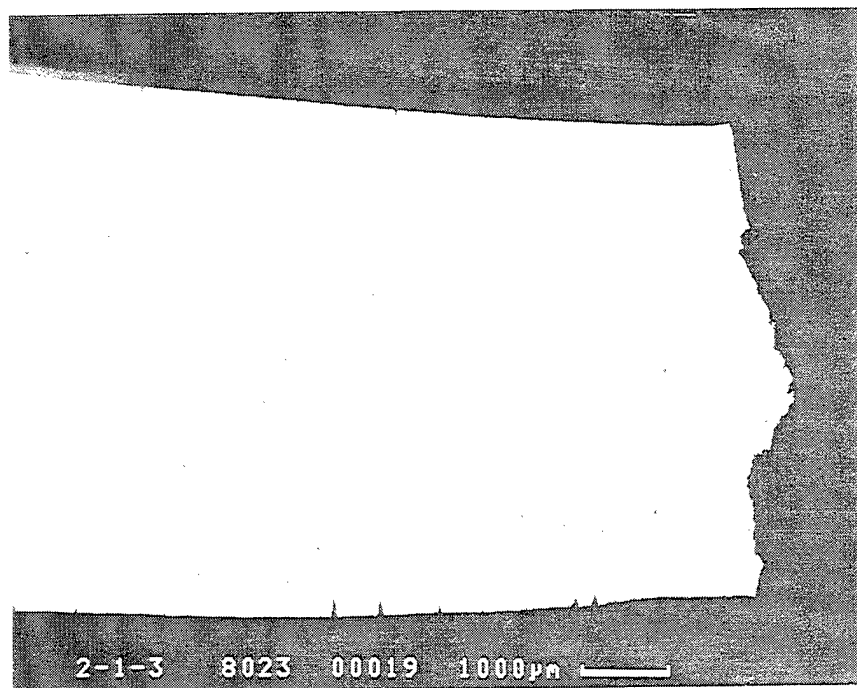
Figure 232. Cross sections of uncoated alpha-2 samples cyclically exposed at 760°C/100Hr after rupture during HSSCC testing. This exposure had no salt.

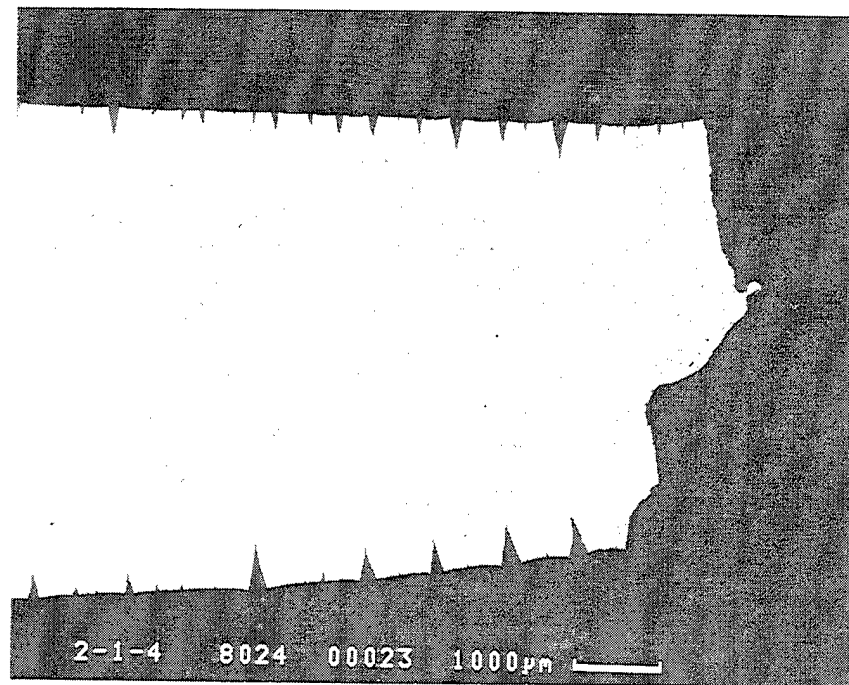
Figure 233. Cross sections of uncoated alpha-2 samples cyclically exposed at 760°C/100Hr after rupture during HSSCC testing. This exposure had salt.

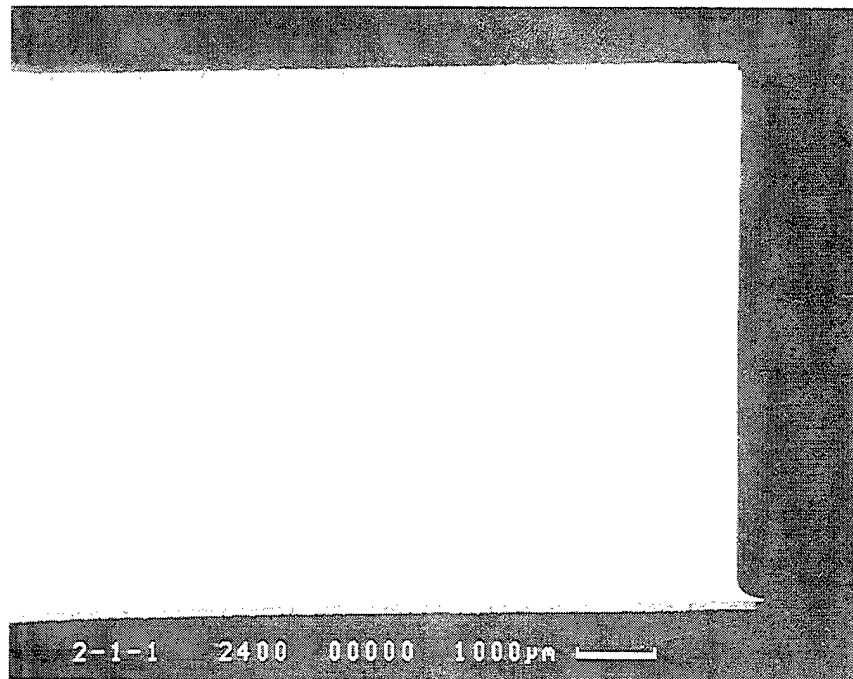
Figure 234. Cross sections of unexposed cermet coated alpha-2 tensile samples after HSSCC testing. This exposure had no salt.

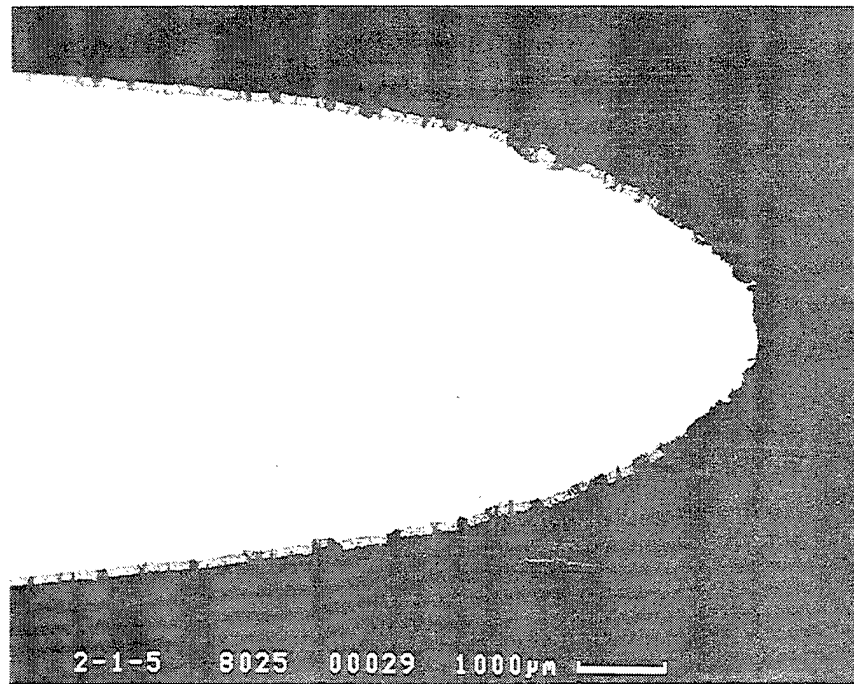
Figure 236. Cross sections of cermet coated alpha-2 tensile sample cyclically exposed at 760°C/100Hr after rupture during HSSCC testing. This exposure had no salt.

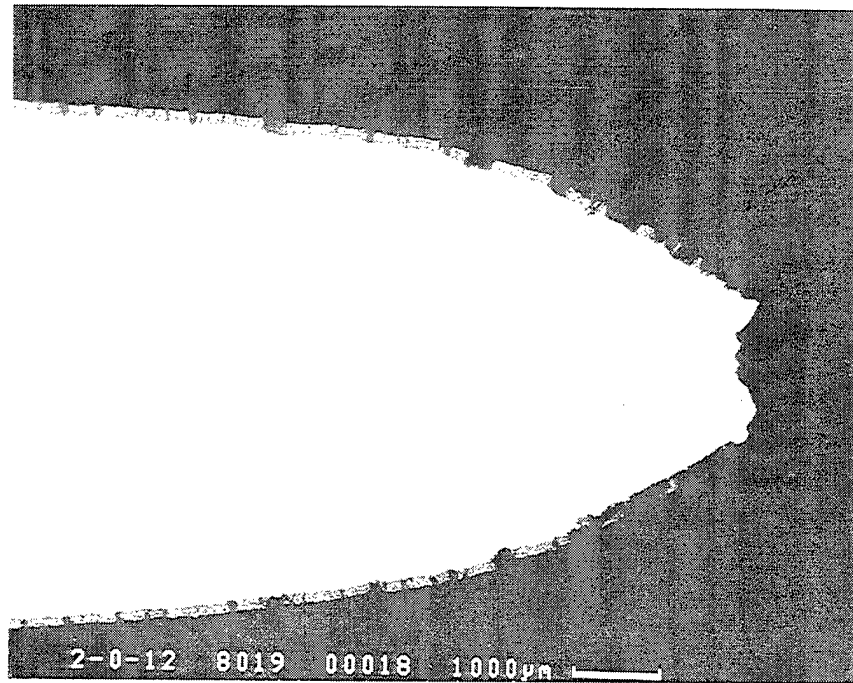
Figure 237. Cross sections of cermet coated alpha-2 tensile sample cyclically exposed at 760°C/100hr after rupture during HSSCC testing.

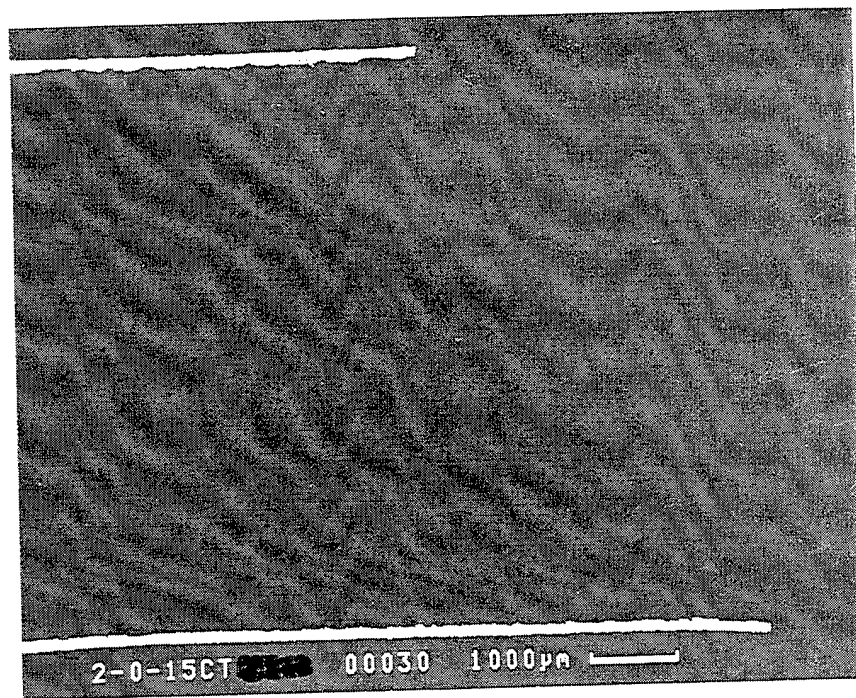
Figure 240. Cross sections of cermet W CVD coated alpha-2 tensile sample cyclically exposed at 760°C/100Hr after rupture during HSSCC testing. This exposure had no salt.

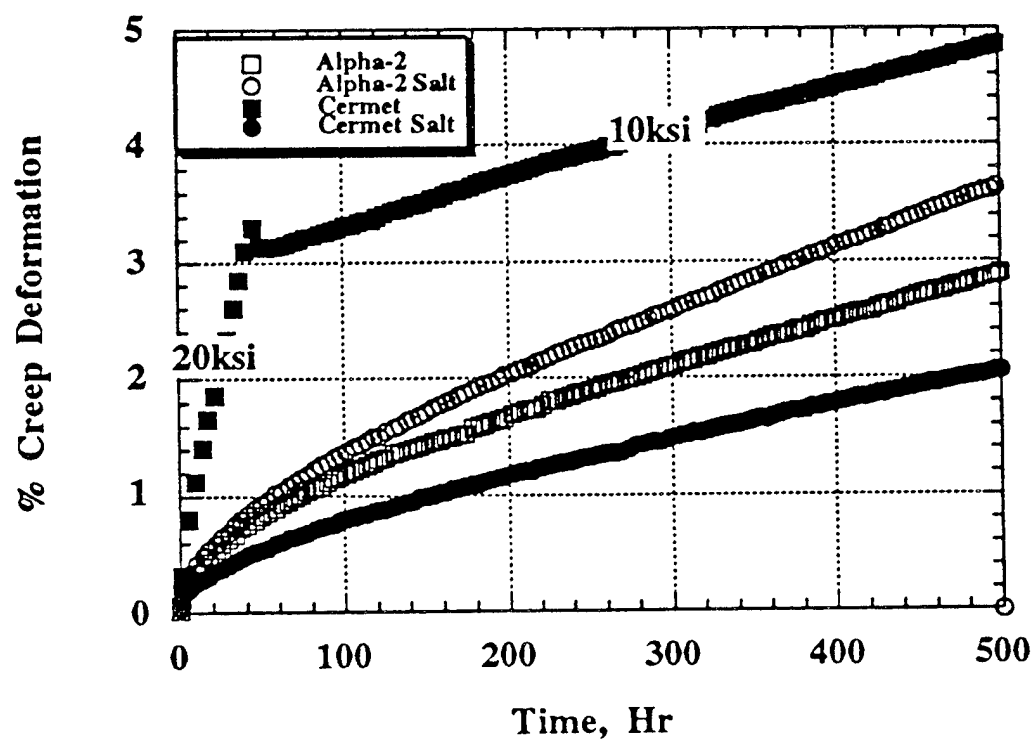
Figure 242. Graph showing creep behavior of unexposed coated and uncoated alpha-2 samples without salt.

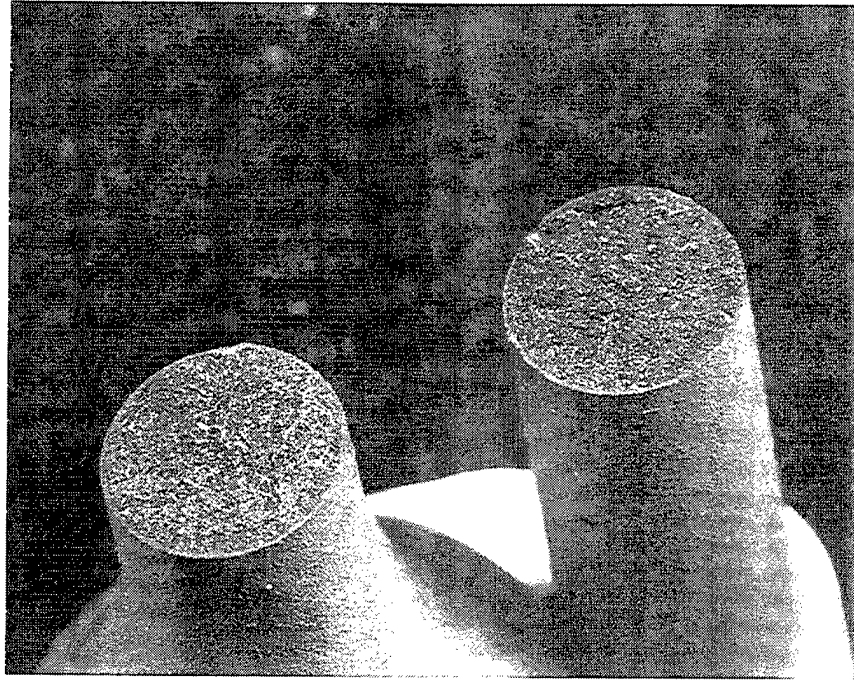
Figure 252. Color photograph of failed gamma bar (19-7-1) tested at 760°C and 0.4% strain for 3 cycles. Auger micrographs of the brown and blue tinted surfaces are shown.

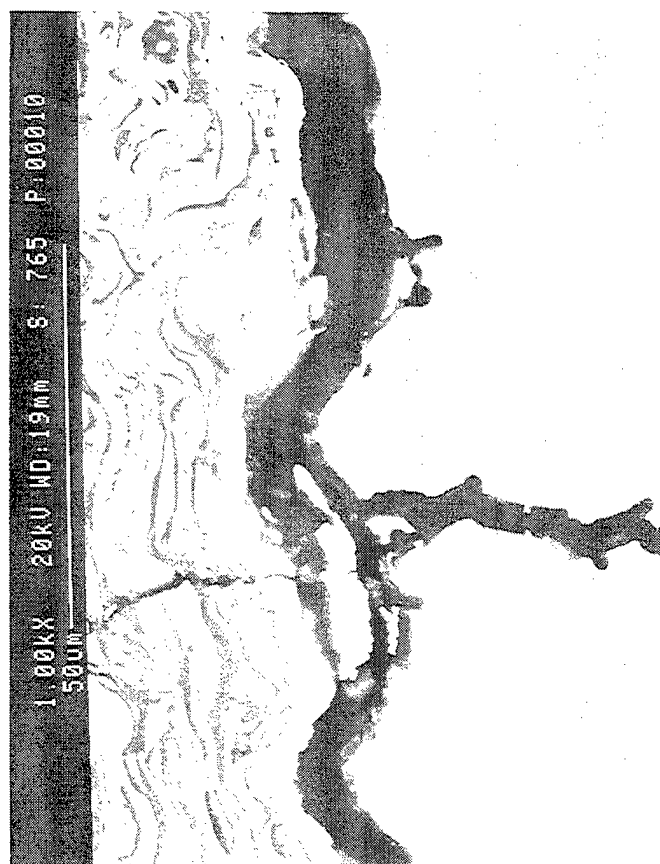
Figure 253. Cross section of CVD W + cermet coated gamma sample fatigue tested at RT and 0.3% strain for 3 cycles.

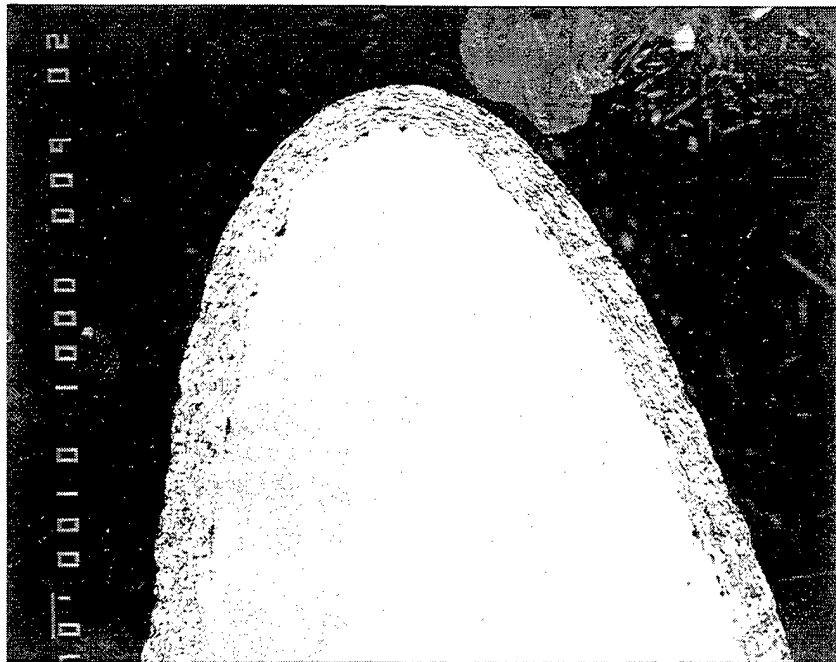
Figure 266. Micrographs of cermet coated Low Pressure Turbine Blade.

The coating conditions selected must be capable of applying the cermet coating to gas turbine hardware. To demonstrate this capability a gamma low pressure turbine blade was coated with the cermet coating. The coated blade is shown in Figure 266 and microprobe results in Figure 267. The coating had an excellent structure with no cracks or large regions of porosity.

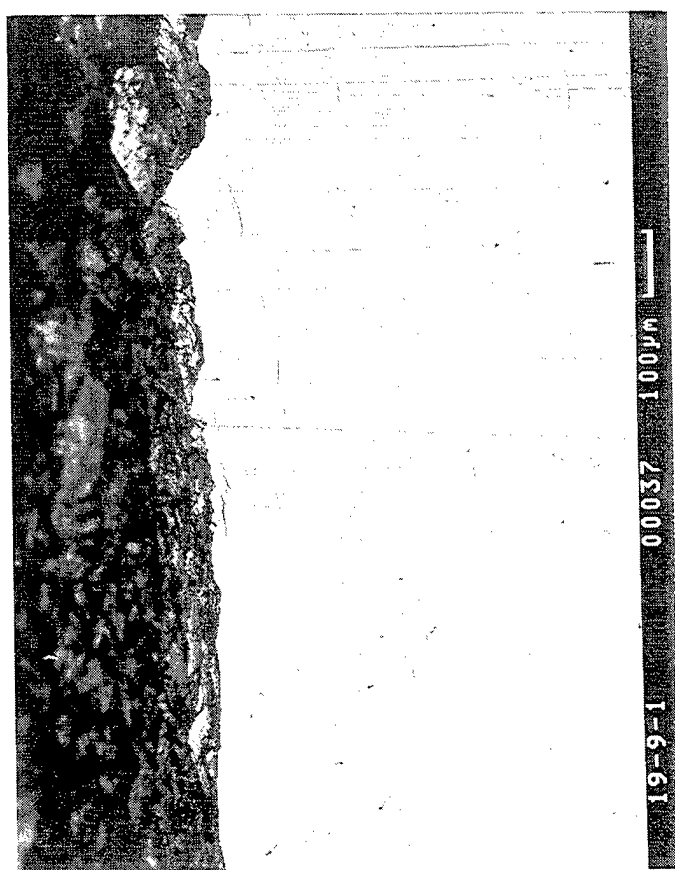
Figure 271. Fractography of the uncoated gamma sample that failed after 108 TMF cycles.
